Roof Inspection Report

LOS ALAMITOS / CERRITOS AVE (20184)

Main Roof Deck Information

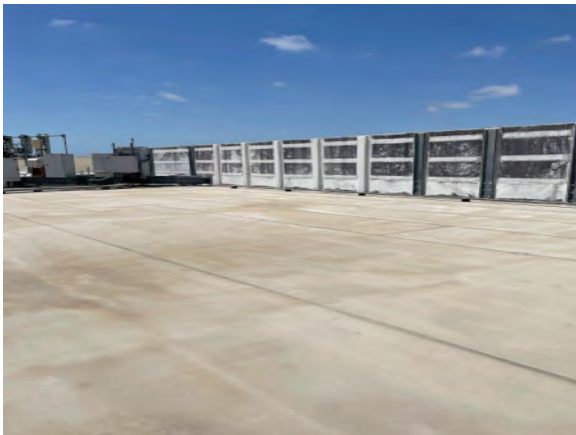
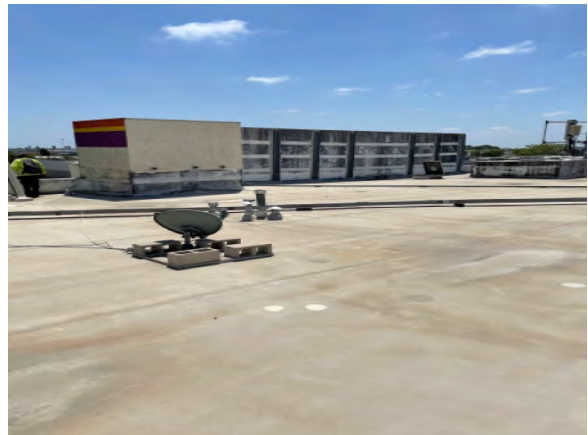
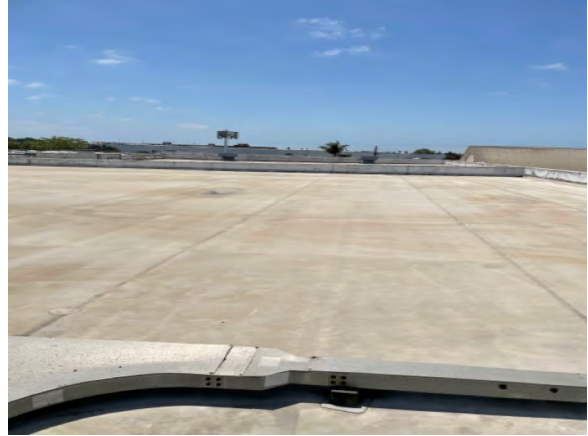
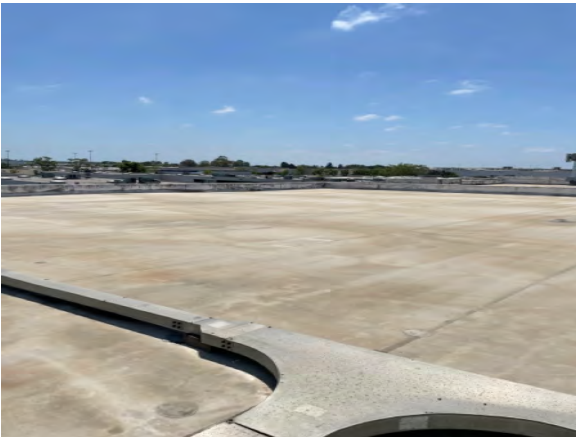
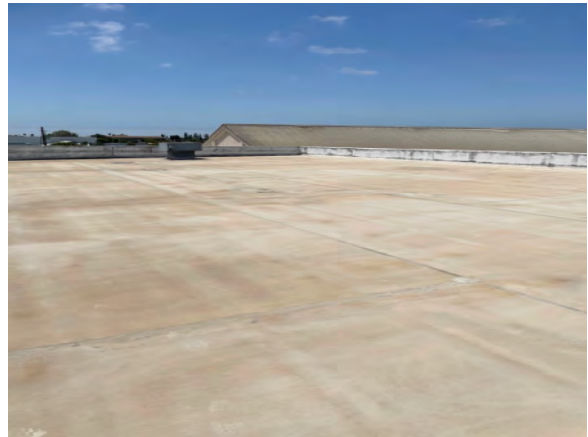
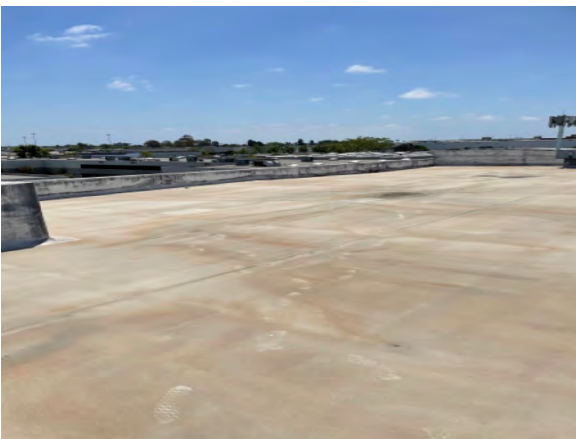
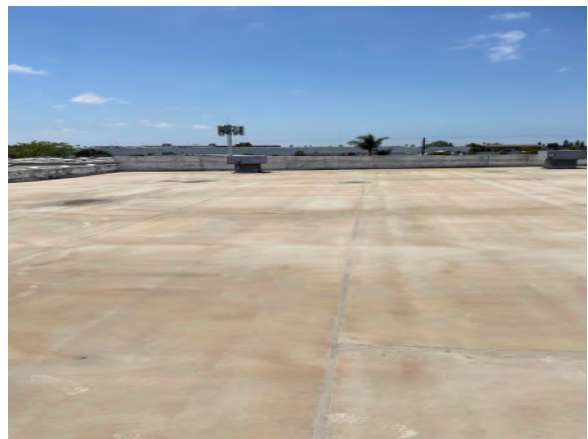
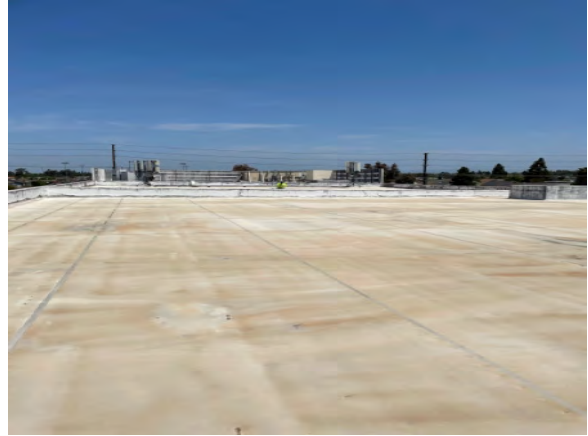
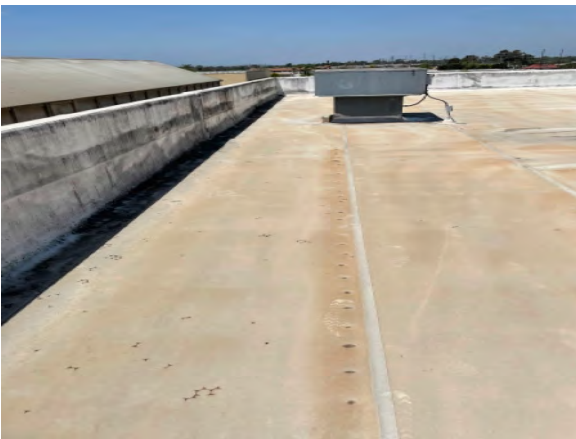
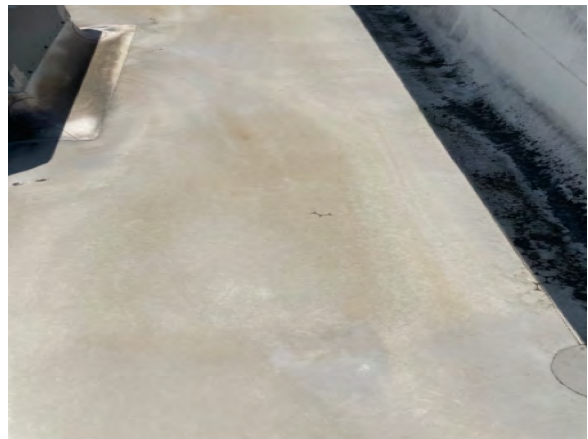
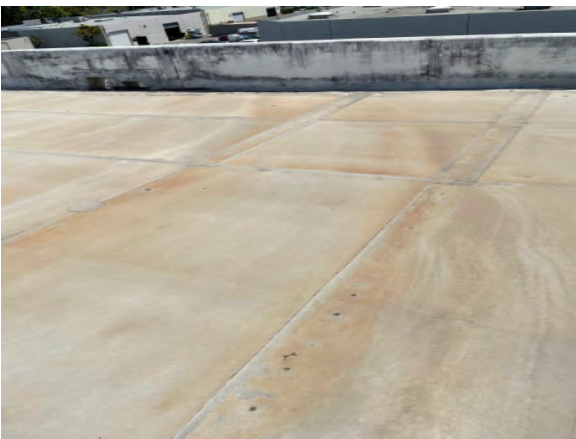
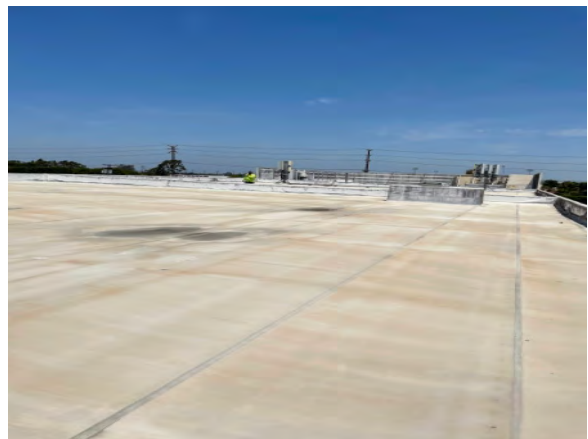
OVERVIEW

Comments: *This roof is Tpo it needs to be replaced, it has a significant amount of damage to it. The single ply is cracking in multiple areas.*

Comments: *I recommend to install a new roof*

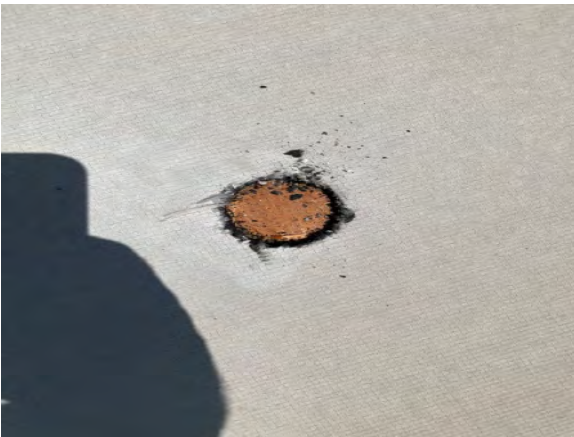
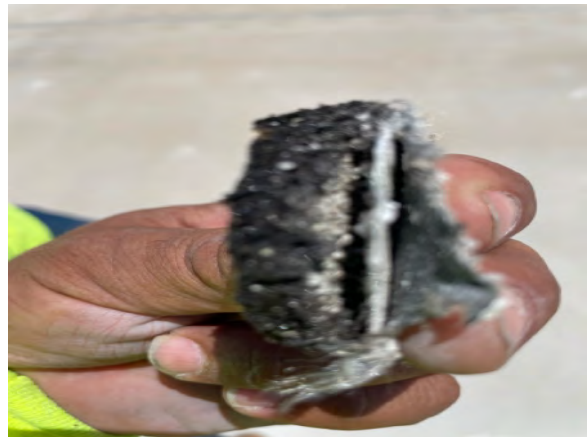
CORE SAMPLE

Comments: *This deck is wood and has two roofs already BUR and TPO.*

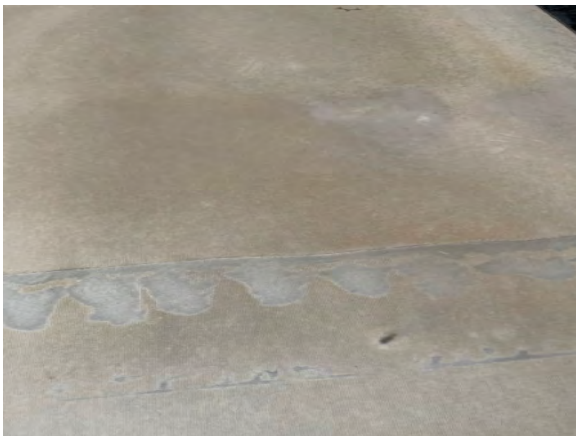
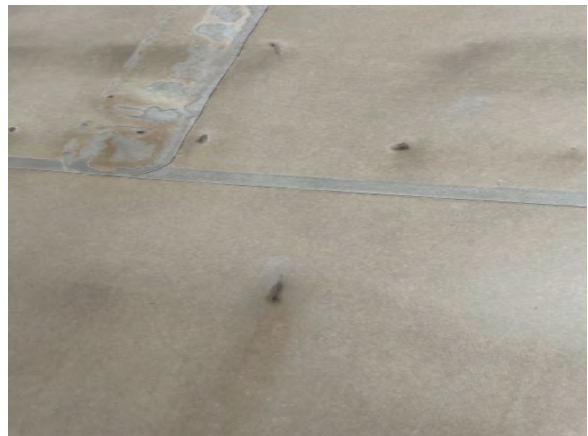
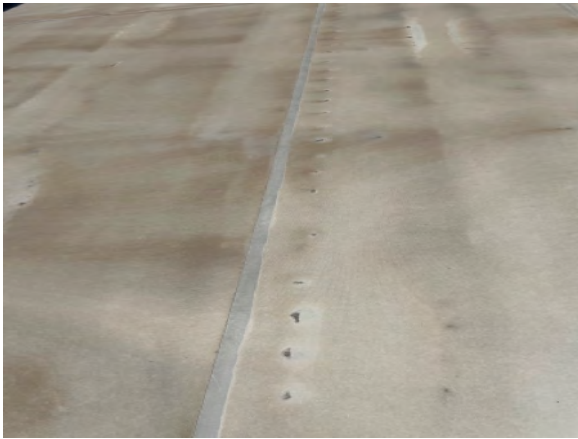
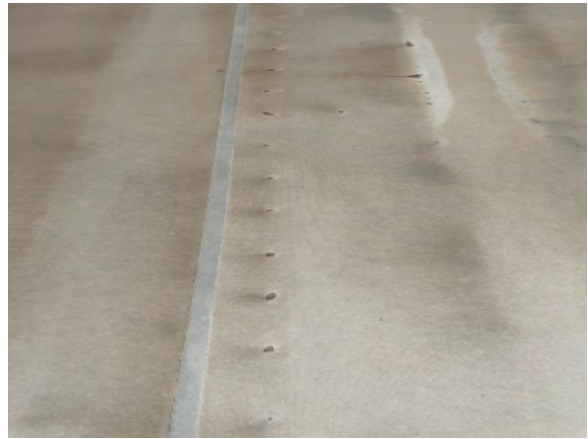
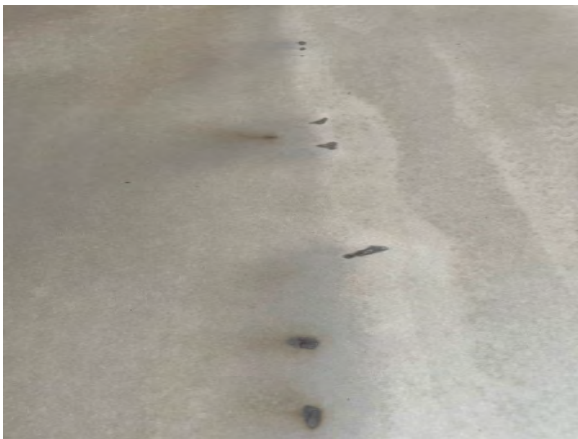
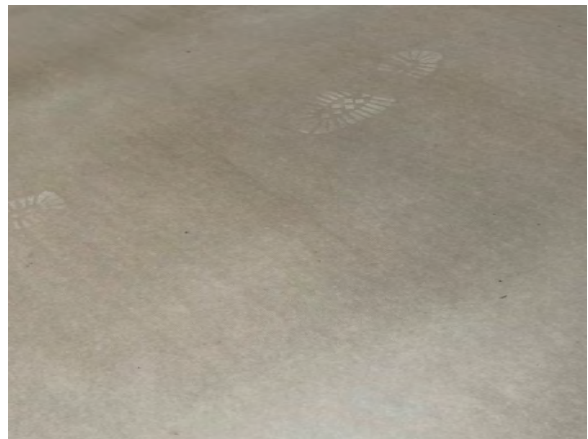
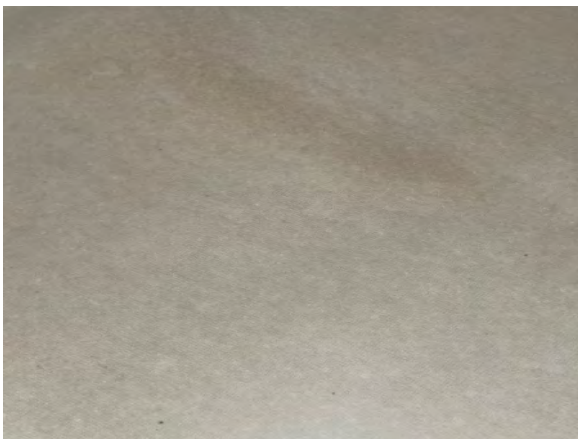
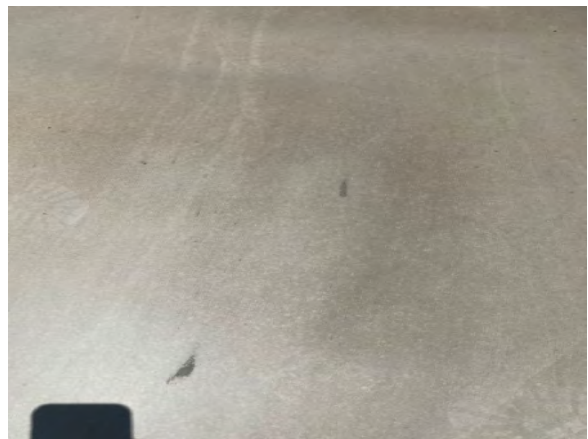
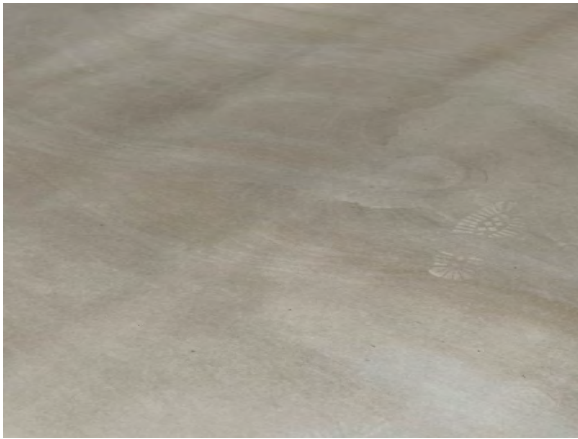
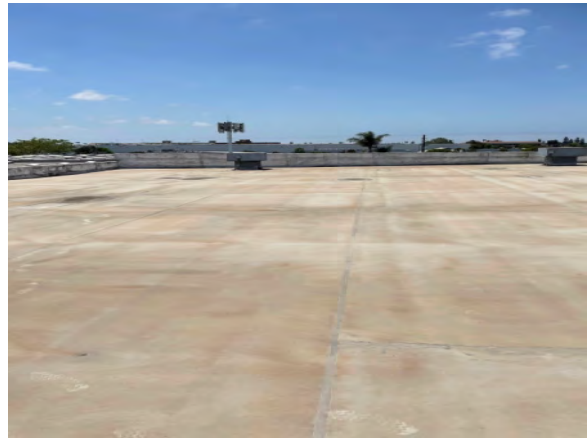
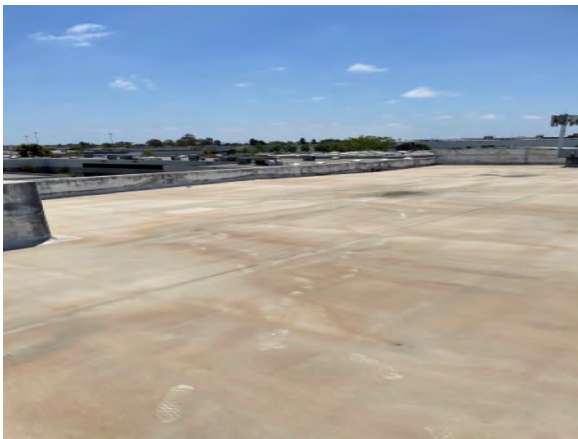
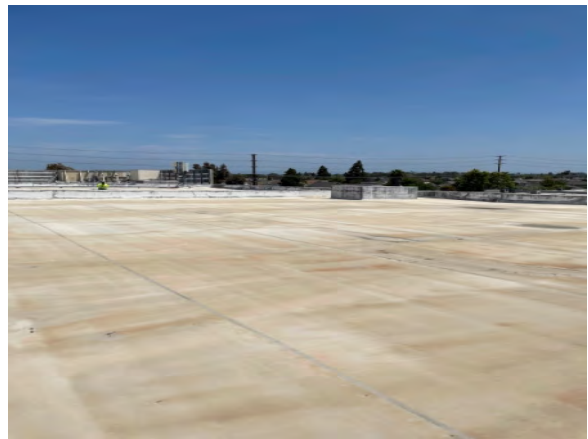
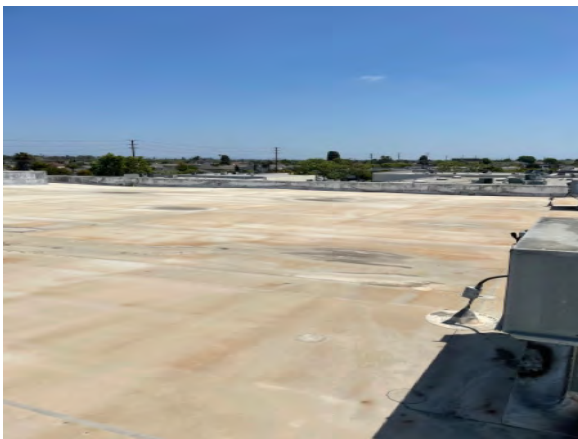
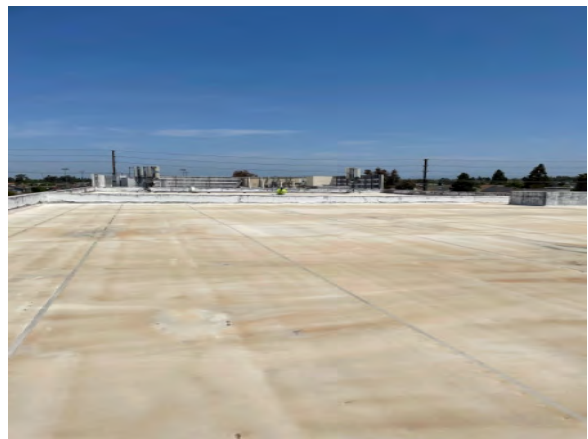
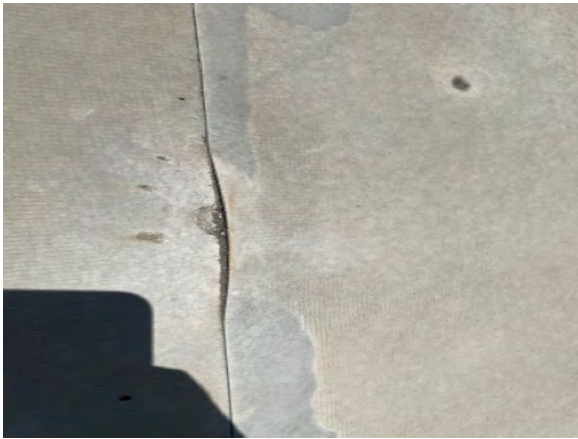
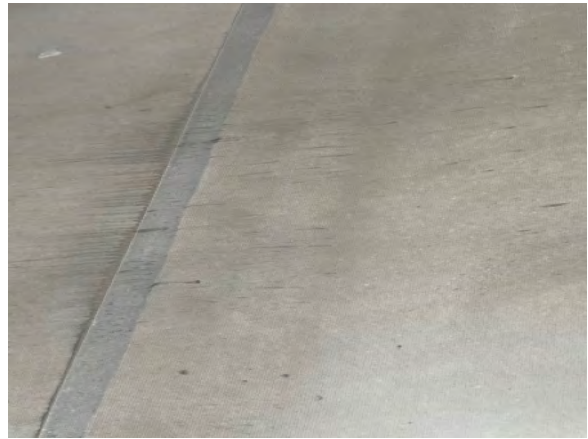
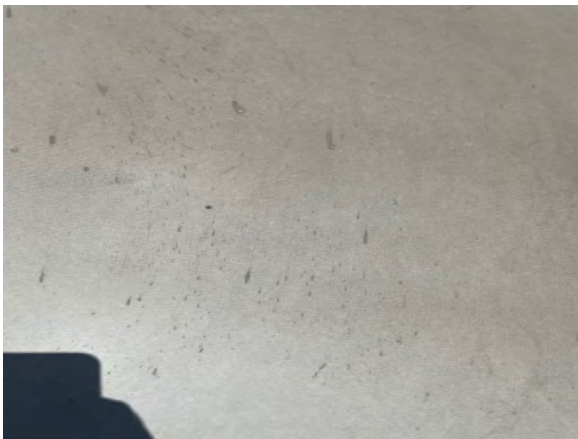
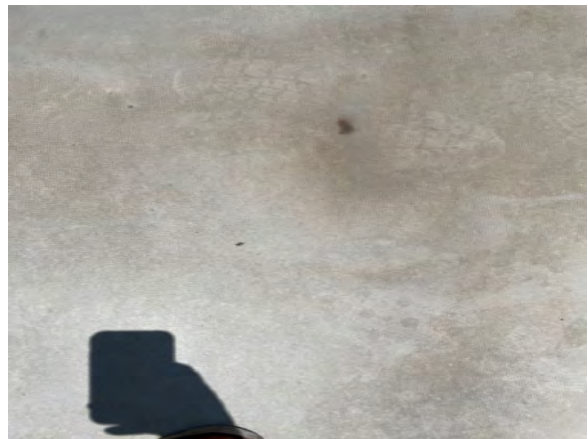
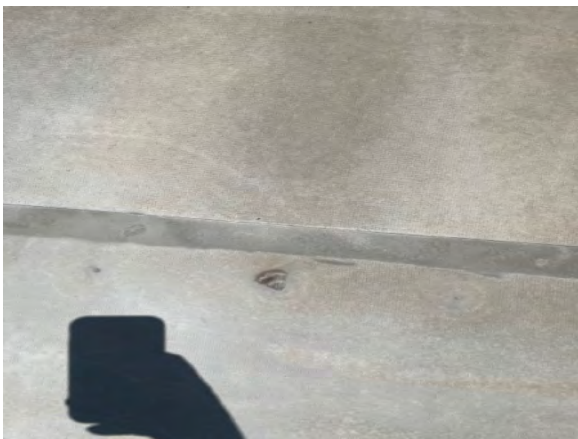
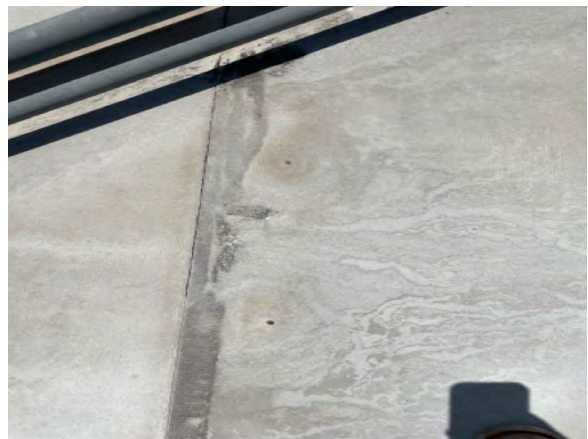
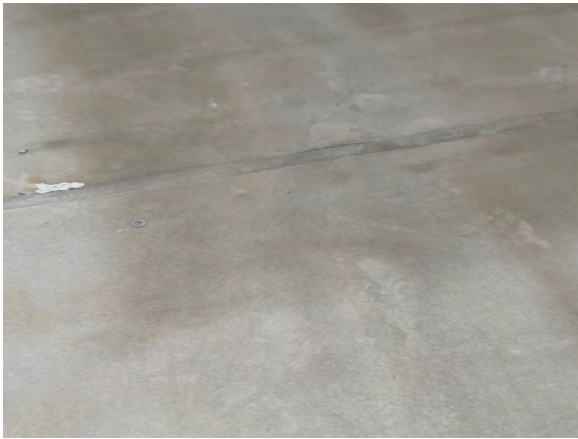
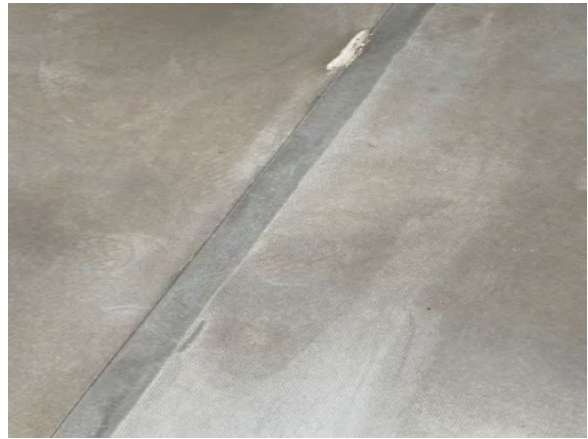
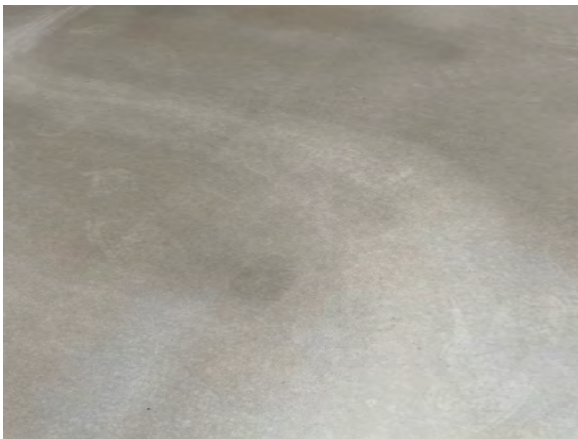
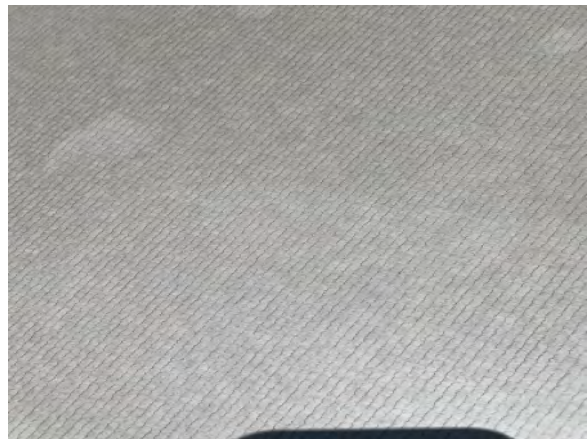
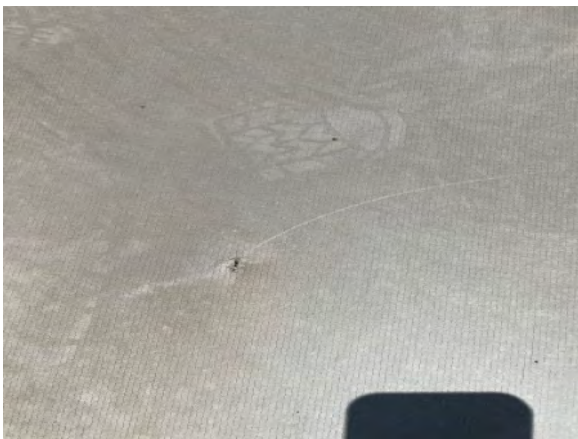
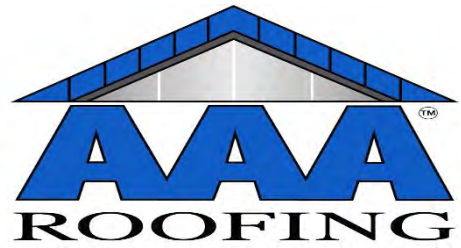
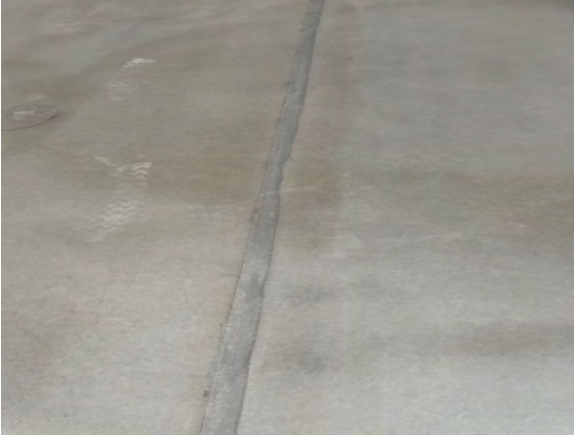
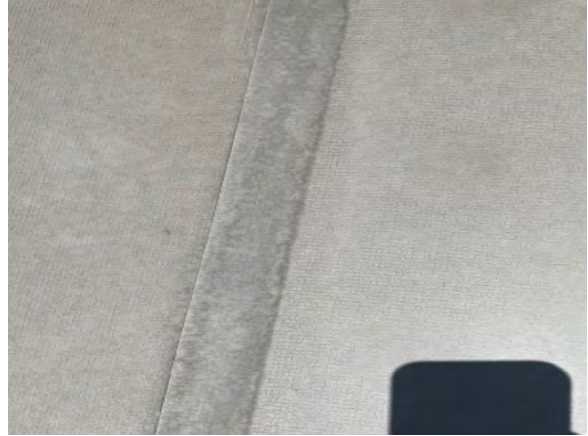
DEFICIENCIES

Comments: *The single ply is to deteriorated already needs a new roof*
