Roof Inspection Report

LOS ALAMITOS / CERRITOS AVE (20184)

Main Roof Deck Information

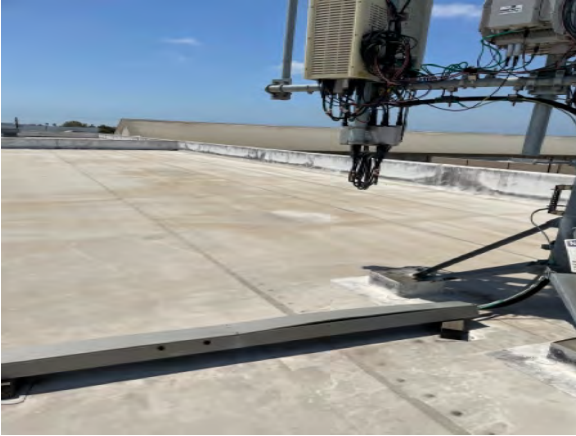
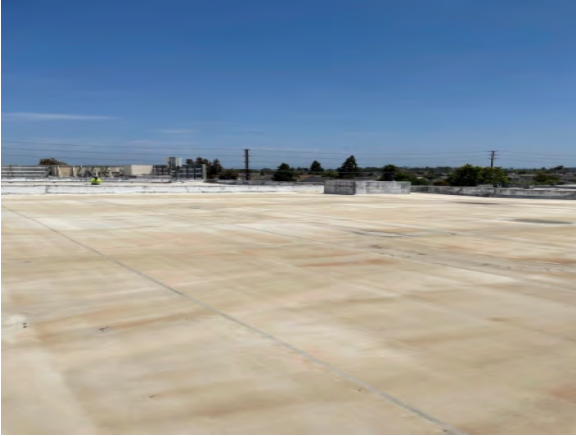
Comments: *This roof is Tpo it needs to be replaced, it has a significant amount of damage to it. The single ply is cracking in multiple areas.*

Comments: *I recommend to install a new roof*
